# *SBCA TREE CONSULTING*

Subject: Tree Removal Recommendation

Location: 1901 Park Street

Species: Indian Laurel Fig (*Ficus microcarpa*)

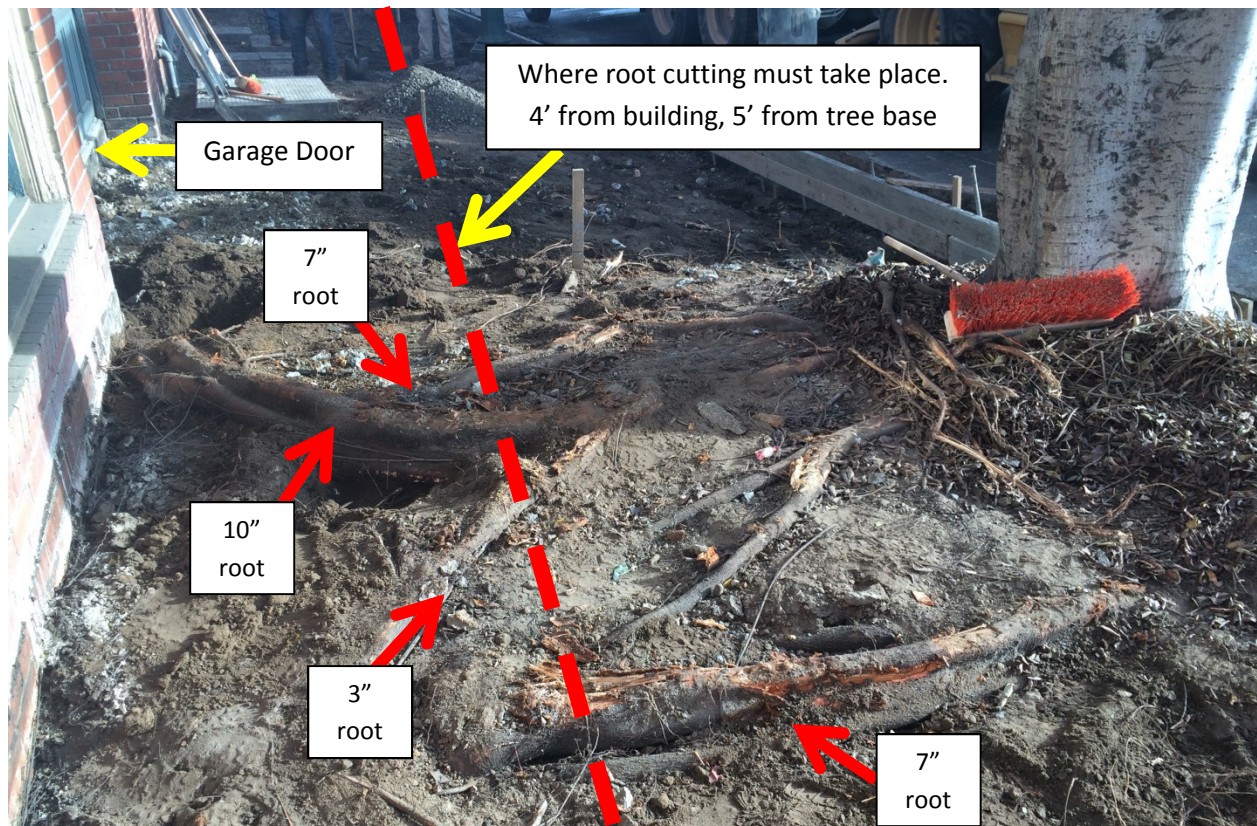
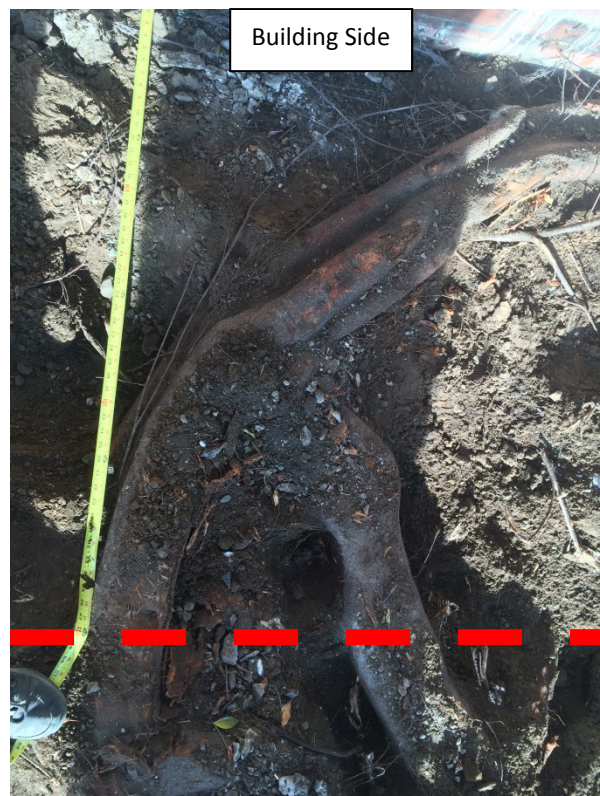
Return sidewalk to grade – It is not possible to return sidewalk to grade without cutting significant roots (including a 10" root and two 7" roots) within the Primary Root Plate<sup>1</sup>. Roots cannot be shaved down as

Root cutting – Park Avenue is a main thoroughfare between Alameda and Oakland. If roots are severed as necessary to return sidewalk to grade, it would likely create a situation with a “moderate to high” risk association<sup>2</sup>. Because the tree appears to lack normal compression roots on the street side, our professional opinion is that the associated tree risk level would be closer to the category of “high”.

**Photos 1 and 2** – Photo above shows the side view of the sidewalk area and where roots are located. In photo to the left, red line indicates where root cutting would have to take place. The large root pictured measured 10" and 7" in diameter.

Remove and Replace Tree – Any attempt to sever the roots and retain the tree would likely represent a risk too high to tolerate. Replacement species should be smaller in stature than the Indian Laurel Fig.
